Santana Project Operations Update

Plant commissioning complete and on track for start of gold recovery this month

Minera Alamos Inc. (the “Company” or “Minera Alamos”) (TSX VENTURE:MAI) is pleased to provide an operational update for the Santana gold mine, Sonora, Mexico.

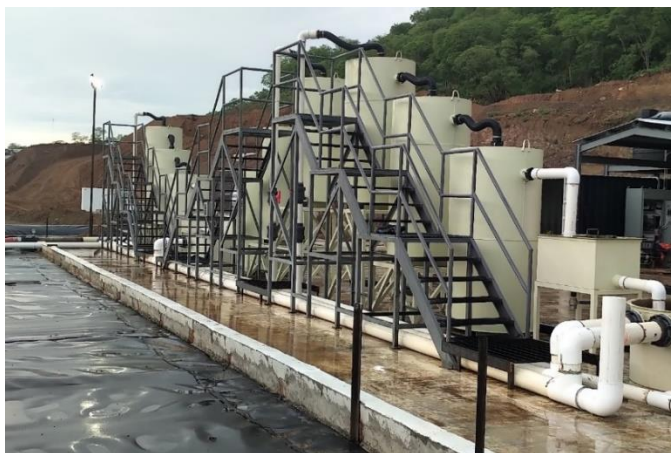
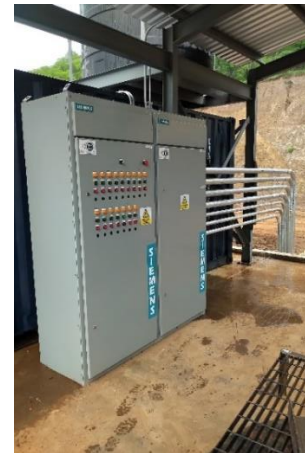
Photo 1 and 2 – The Santana gold recovery (carbon) plant / Electrical Control

- Leach solution pumping and processing systems are all available and have been thoroughly tested during normal commercial operational flowrates in order to calibrate process instrumentation and test control systems and interlocks. Some minor adjustments have been identified which offer the potential for improvements but these changes will be implemented during normal operations.

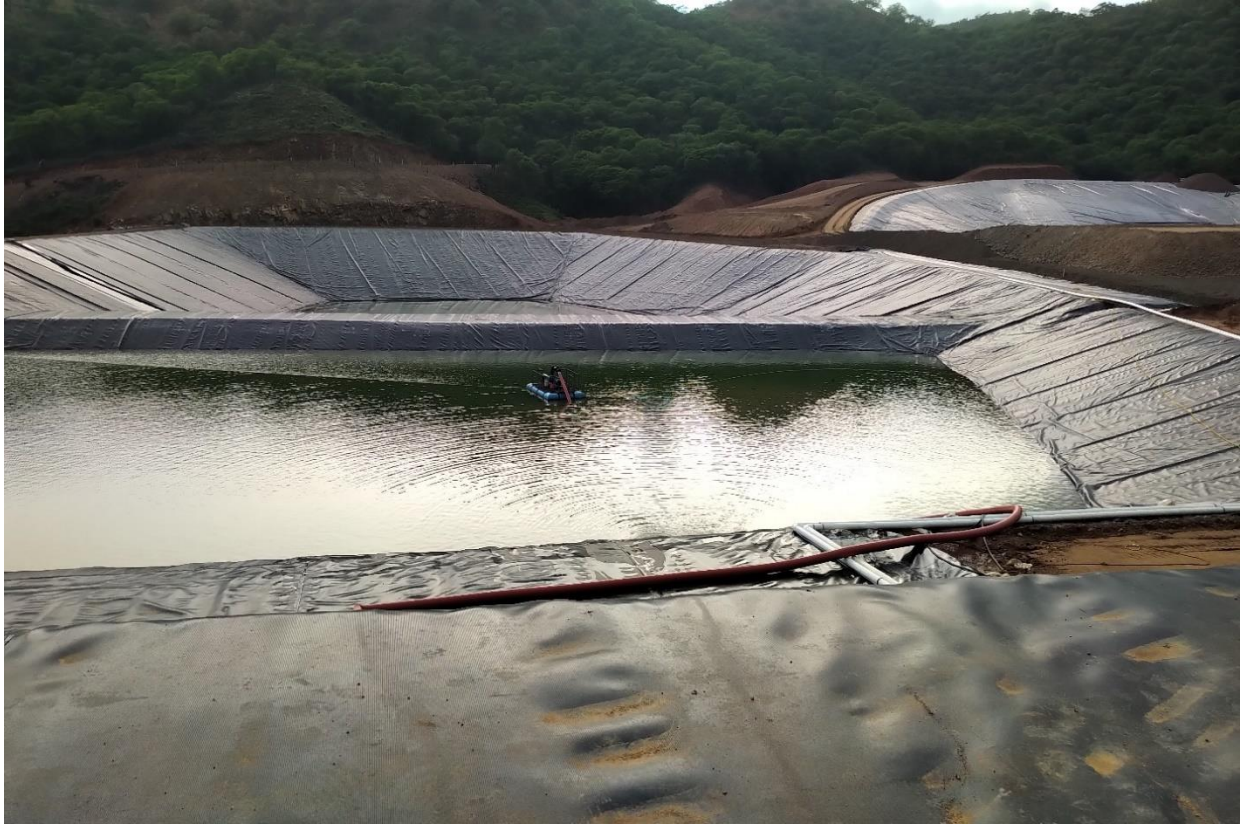
Photo 3 – The pregnant solution pond with floating pumping system in place and operational

- Excess rainwater contained in the pregnant pond (pictured below) is currently being transferred to the barren pond to avoid unnecessary dilution of gold leach solutions. Upon completion, reagents will be added to the process solutions to initiate the extraction of gold from the initial material placed on the heap leach pad and to test the overall leaching and recovery circuits as part of the normal start up of operations.
